EFFECTS ON A VEHICLE IMPACTING A
CONCRETE SAFETY SHAPE BARRIER AT
A LOW SPEED AND A LARGE ANGLE

1. REPORT NO. CA/TL 86/02		2. GOVERNMENT ACCESSION NO.		3. RECIPIENT'S CATALOG NO.	
4. TITLE AND SUBTITLE Effects on a Vehicle Impacting a Concrete Safety Shape Barrier at a Low Speed and a Large Angle				5. REPORT DATE July 1986

The following conclusions are based on the results of an 1860 lb vehicle/27.4 mph/52° impact test, Test 431, into a safety shape concrete barrier.

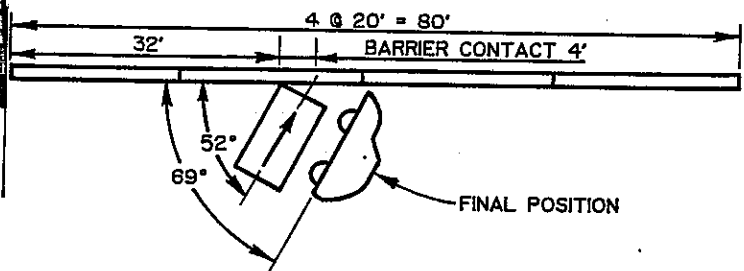
FIGURE 5 - Vehicle Damage

Damage to the vehicle was relatively severe. Immediately after impact the left front quarter panel was crushed and buckled above the tire. The front bumper was crushed toward the right side of the vehicle. The

left side of the hood was crushed back and the hood opened. The left front headlight was crushed, and the front frame members under the engine were bent. The left front tire was flat, and the rim was scraped and bent, Figure 5. The left inside door panel was dented and bent forward (out) from impact by the dummy, Figure 6. The left door post from the upper front corner to 6 inches down its length, was struck by the dummy head, and bent 1/2-inch forward. During the redirection of the car, the left side was scraped. Paint from the side of the vehicle was transferred to the upper half of the barrier on an area about 20" long and 10 inches high. There was no intrusion of barrier or vehicle components into the passenger compartment. The steering wheel was bent about 6 inches toward the windshield from the impact of the dummy.

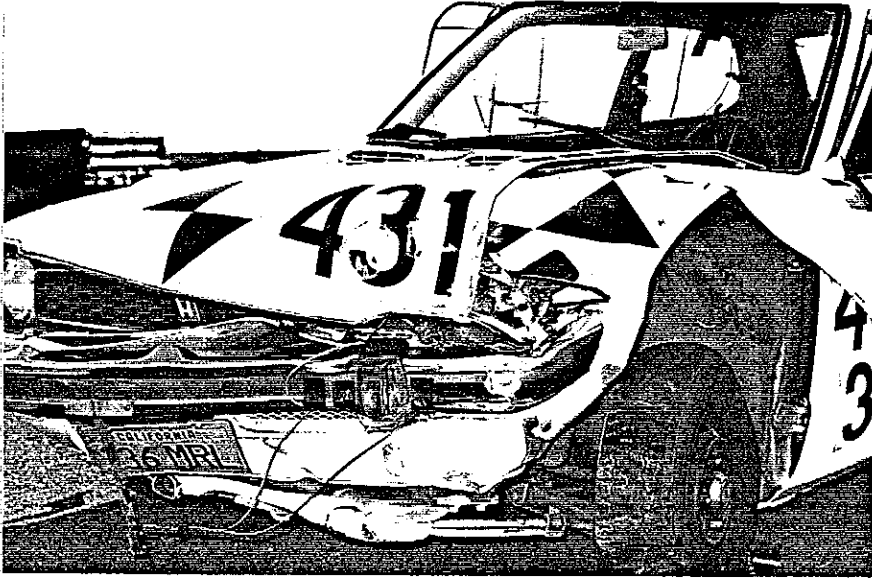
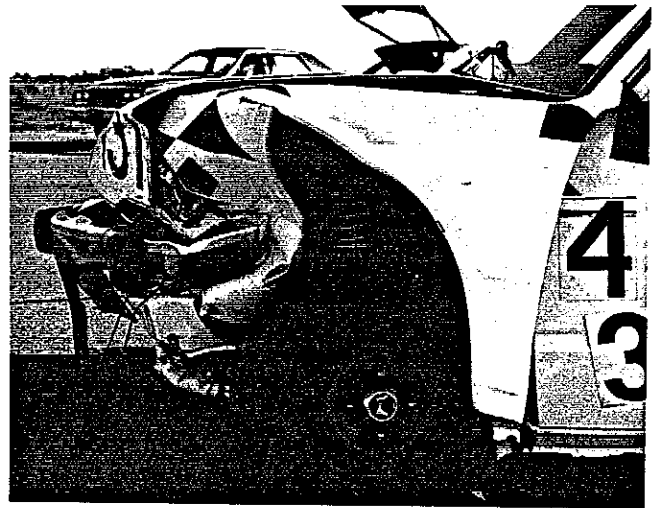
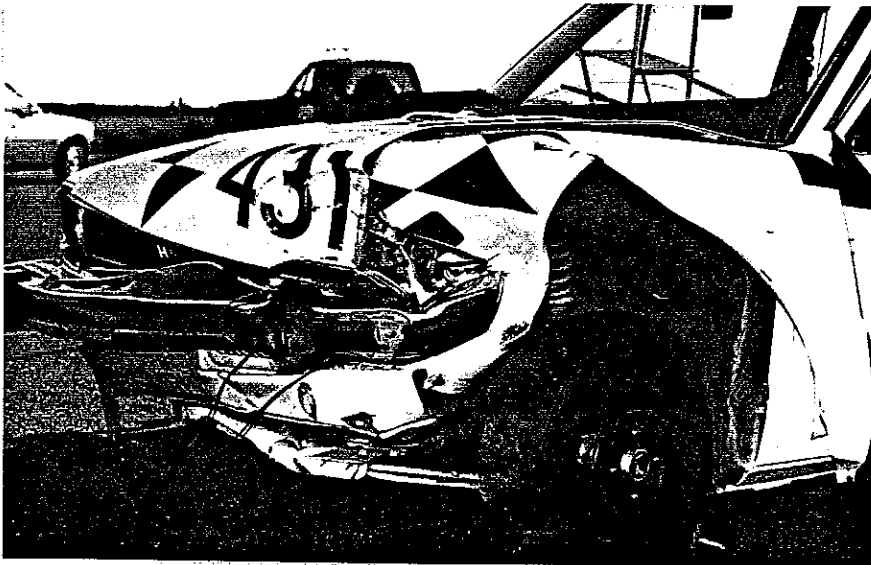
FIGURE 6 - Post Impact Views

During impact, the unrestrained 5th percentile female dummy, which was in the driver's seat, was thrown forcefully ahead into the steering wheel bending it and pushing it forward six inches from its original plane. The steering column was forced down. The dummy continued to move toward the left front corner of the car, and hit the left front door post, bending it. Then it was thrown to the right toward the passenger seat as the car rolled over to the right. After impact the dummy was laying across the front passenger seat with its legs wedged under the steering wheel, Figure 6.

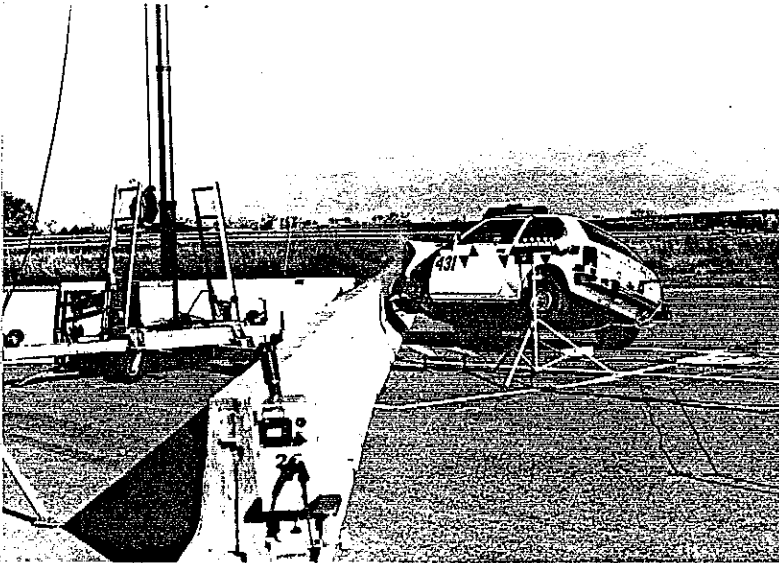
Vehicle Climbing
Barrier and Rolling
During Impact

During impact, and immediately after, the vehicle rode up the face of the barrier and across the face while rolling steadily clockwise to its right side. There was no intrusion of the passenger compartment when the car rolled over. If the camera rack had not been mounted outside the passenger door, the car would have continued to roll with the possibility of greater vehicle damage and more severe injuries to passengers.

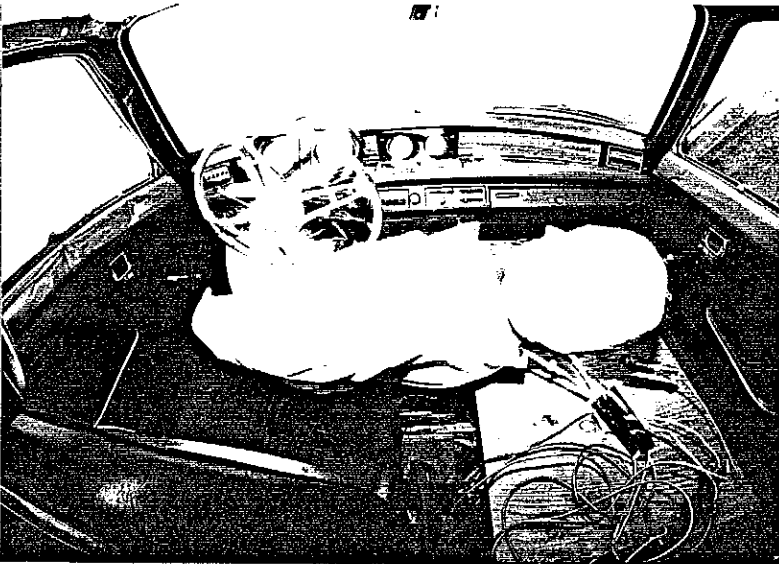
Dents in Door
and Doorpost Due
to Dummy Impact

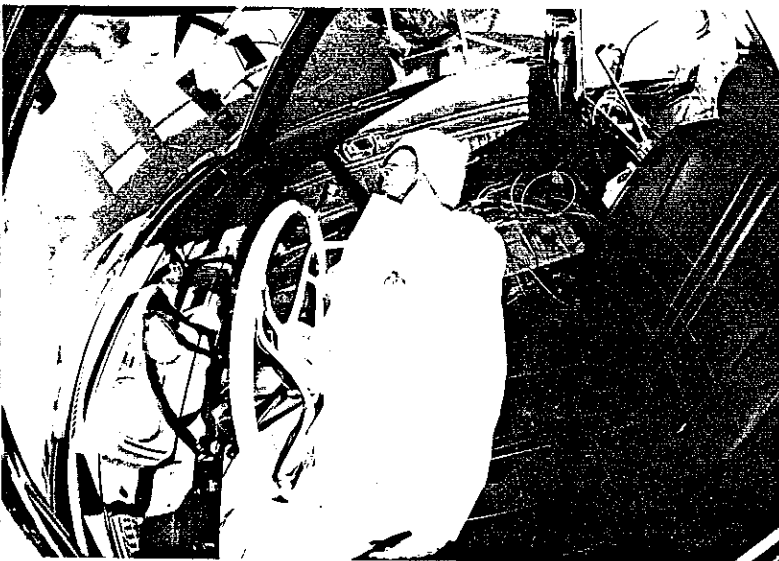
Final Position of Dummy
After Impact

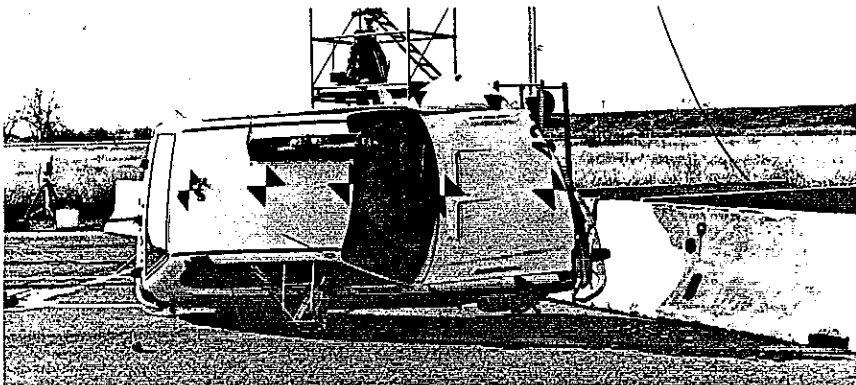
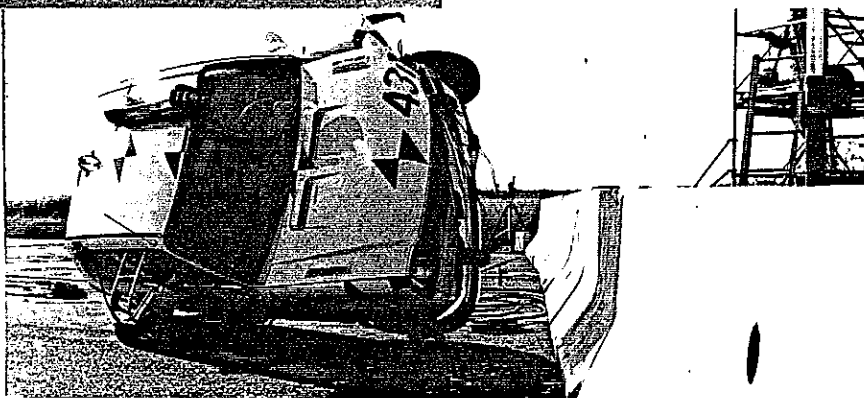
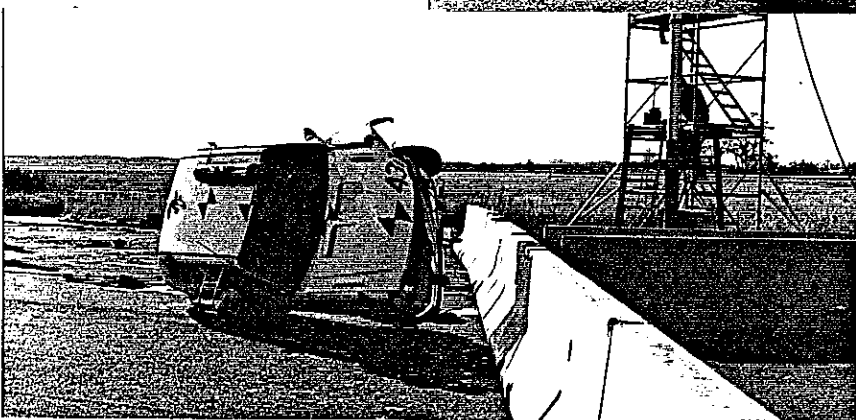
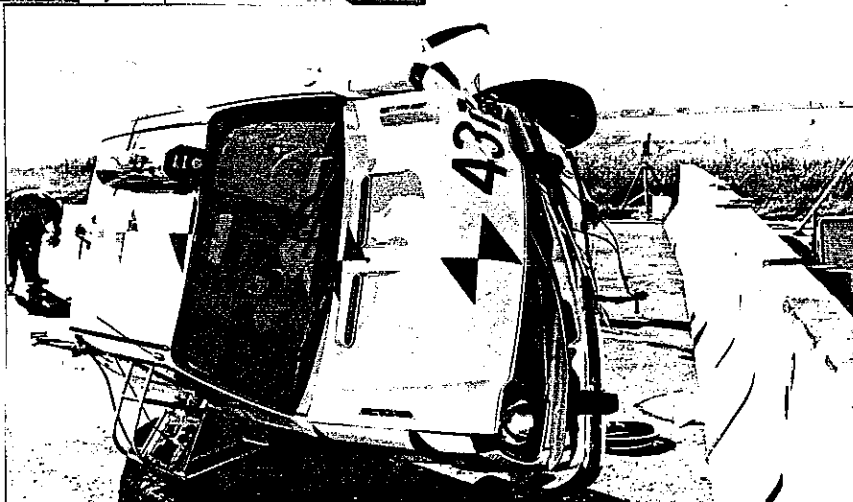
Figure 8 - Final Position of Vehicle After Impact

The vehicle remained on its right side at an angle of 69 degrees with respect to the center line of the barrier. The horn became stuck when the dummy struck the steering wheel and the dashboard.

In test 431, the final resting position of the test vehicle after impact is shown on the Data Summary Sheet, Figure 4, in the Test Results section of this report and in Figures 6, 7 and 8. The test vehicle rode up the face of the barrier and across the face while rolling steadily clockwise to its right side where it rested, lying on the camera rack hanging on the right window. The vehicle remained on its right side at an angle of 69° with respect to the center line of the barrier. Rollovers do not meet the safety evaluation criteria for highway safety devices according to NCHRP Report 230. Hence, it is clear that this impact was extra hazardous due to the rollover.

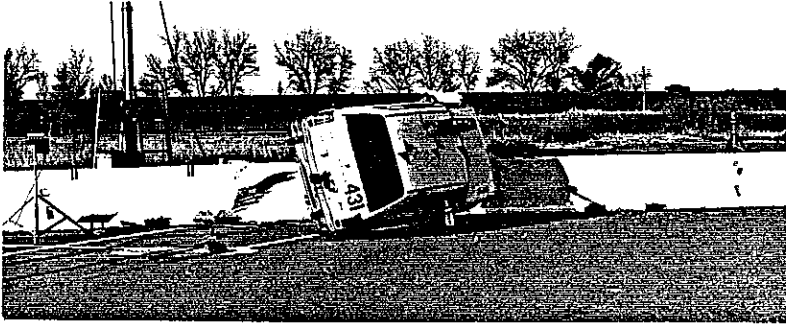
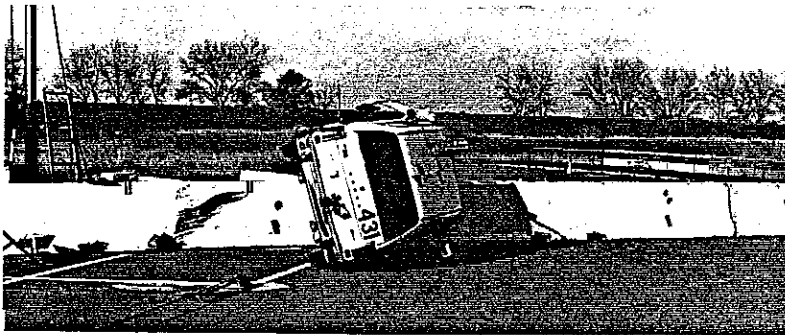
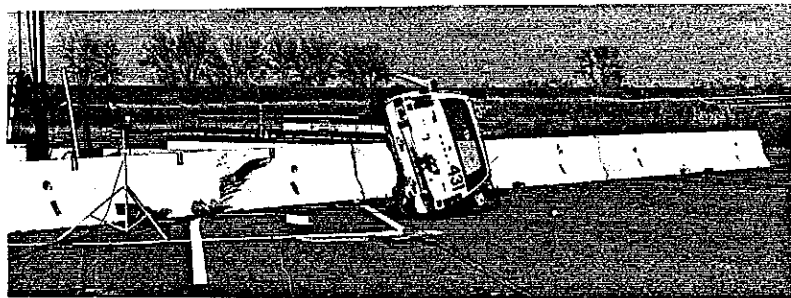
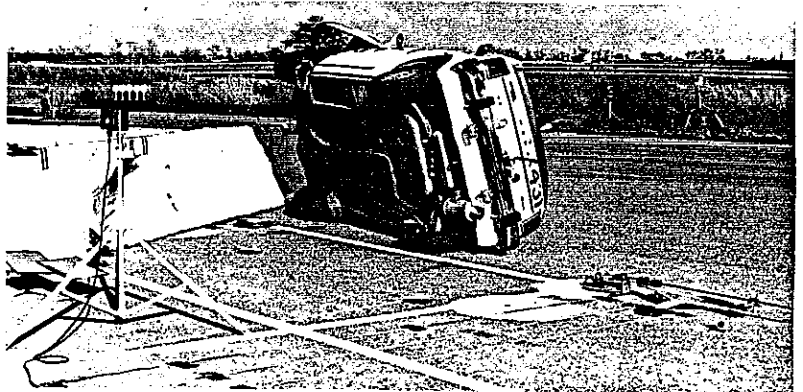
Figure 9 - Car Tire Marks on the Barrier

There was no evidence of any structural failure of the barrier. No visible cracks were detected. The only damage imparted to the barrier was a few scrapes and tire marks, Figure 9.

Criteria A and D - passed. The test barrier did not fail structurally. There were no visible cracks in the barrier. Other than tire marks, minor sheet metal scrapes, all of which would require minor maintenance

repair, the test barrier suffered no damage. No barrier debris intruded into the passenger compartment of the vehicle during the test.
